Manhole Inspection Summary

Manhole # S21MM1001MH

Insp Date: **11/9/06 7:44 AM**

Location Address: **1503 OLD COLD SPRING LN** Cross Street: **CLYDESDALE AVE**

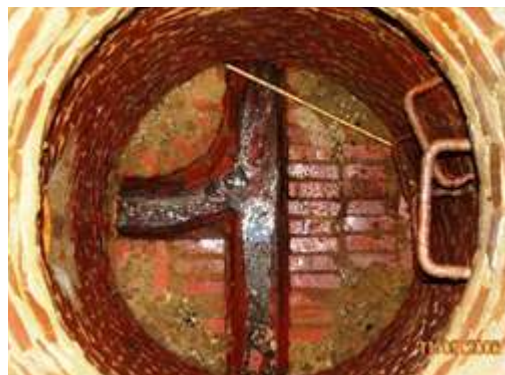
Top View

Bench ☒ Exists Material: **Brick** ☐ Parged ☒ **Debris** (not Condition related)
Condition: ☒ Sound ☐ Cracked ☐ Root Intrusion ☐ Deteriorated ☐ Leaks ☐ Debris

Steps Count: **4** Missing: **0** ☒ **Corroded**

Corroded steps. Bench debris.

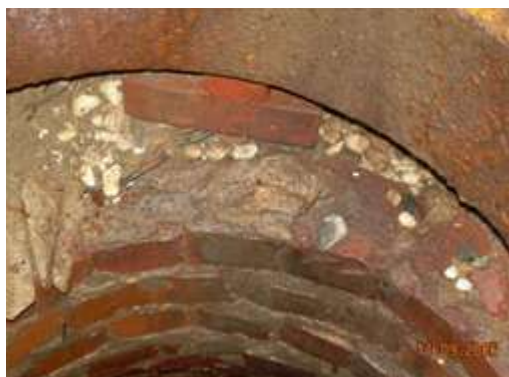
Defect

Frame Offset: **4** (in.) Condition: ☒ Sound ☐ Cracked ☐ Leaks

Chimney / Frame Adjustment ☒ Exists Material: **Brick** ☐ Parged Height: **18** (in.)
Condition: ☐ Sound ☐ Cracked ☐ Root Intrusion ☒ **Loose Brick** ☒ **Deteriorated**
Infiltration: ☐ None ☒ **Joint** ☐ Cracks ☒ **Mortar** ☐ Roots ☐ Wall

Frame offset. Adjustment deterioration, loose brick and infiltration.

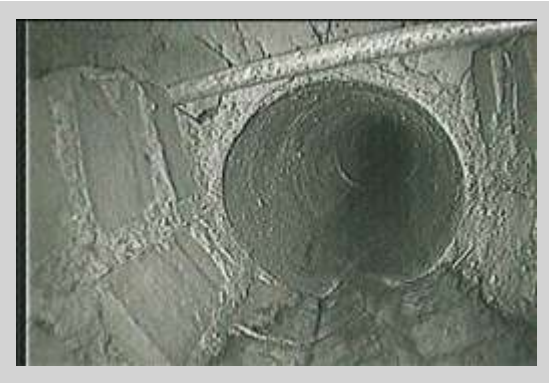
8 in. Circular Gravity Sewer Pipe Out @ 12 O'Clock

Pipe Material: **Clay** ☐ Pipe Lined

Invert Depth: **9.80** (ft.) Flow Characteristics: **Slow**

Infiltration: **None** Pipe Seal Cond: **Unknown**

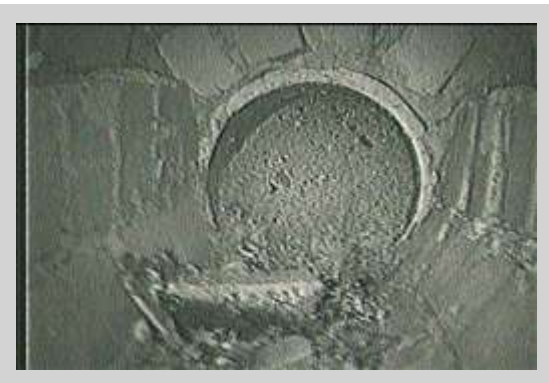
8 in. Circular Gravity Sewer Pipe In @ 6 O'Clock

Pipe Material: **Clay** ☐ Pipe Lined

Invert Depth: **9.80** (ft.) Flow Characteristics: **None**

Connects To: **Stub connection / abandoned**

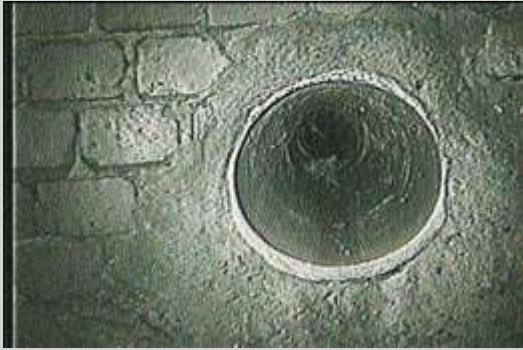
Pipe In @ 9 O'Clock

Pipe Material: **Clay**

Invert Depth: **6.14** (ft.) Flow Characteristics: **Slow**

Infiltration: **None**

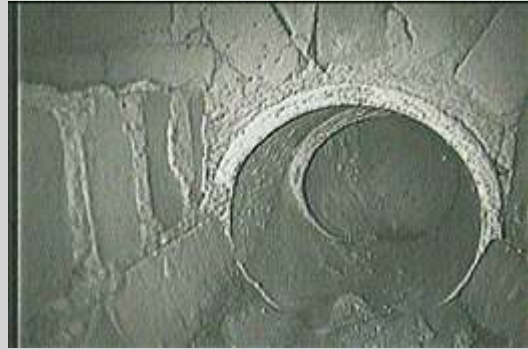
Drop In @ 9 O'Clock

Drop: **Outside** Rod and Bar

Angled: **Yes** Reading: **8.70** (ft.)

Inv Depth: **9.70** (ft.)

Drop Condition: **Open**
